Assessment of Dome Building Damage and Repair Method

ASSESSMENT OF DOME BUILDING DAMAGE AND REPAIR METHOD

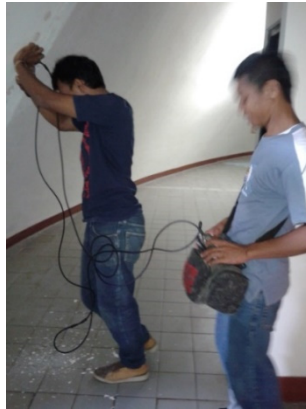
Figure 1: UPV test

Ultrasonic pulse velocity (UPV) test is intended for observing the uniformity of existing concrete and existency of cracks. Indirect method was applied (Fig.1) The UPV test were carried out at five location to observe dome concrete crack region.

The UPV test results show that the crack depth in the dome building is 65-100 mm. The crack depth of 65-100 mm occurred larger than the concrete cover is 50 mm. This indicates the cracks a structural crack. So it needs repair by injection with epoxy material. Based on 4 samples of coring tested press obtained concrete strength f_c 20 MPa

To overcome cracks that occur the first step of Injection with epoxy material using a special tool pressurized. the epoxy point distance is 250 mm. injection performed from bottom to top

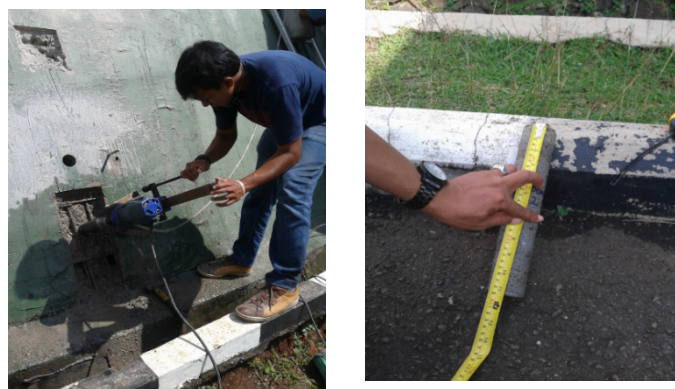
Figure 2: Core Drilling

Core drilling (Fig.2.) is intended for obtaining specimen out of existing concrete was before test in laboratory to find compression strength of concrete. The size of specimen cylinder is 200 mm height and 100 mm diameter. Coring is performed along the dome around 8 points with a height variation of 50 mm and 100 mm from the dome base.

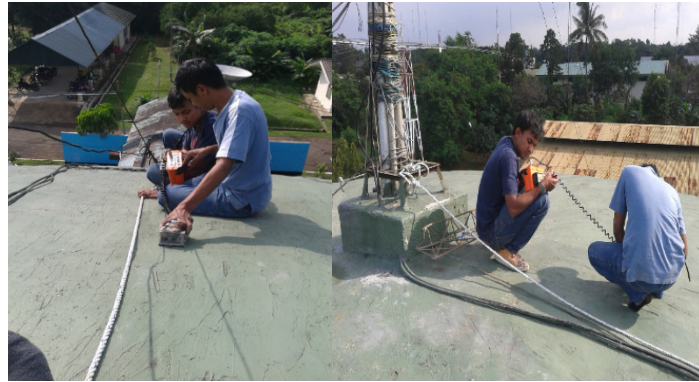
Figure 3: Profometer Testing

Profometer test is intended for inspecting the existing dimensions and spacing of the reinforcing bars. The testing was carried out at eight locations ranging from a height of 500 mm from the bottom to the top of the dome. See Fig. 3 as explanation. The results are Meridian reinforcing 2 D13 with 10 cm distance and 10 mm diameter longitudinal reinforcement with 30 cm distance.

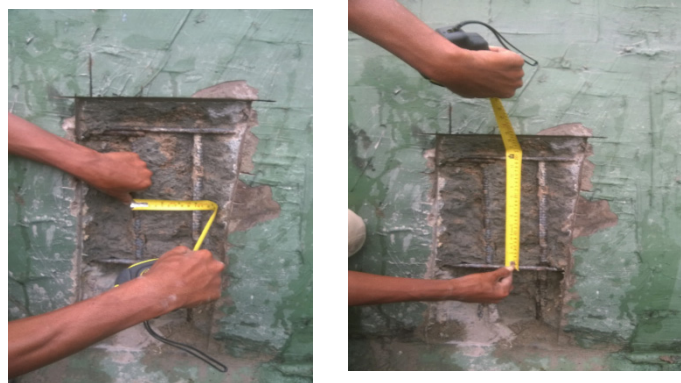
Figure 4: Destructive Test

Destructive test carried out was chipping of concrete so as to be able to inspect the size and spacing of reinforcing bars (Fig.4). The results were then compared to the ones obtained out of profometer test, which turned out to be the same result with the test results of the profometer.

The Destructive test results show that the meridian reinforcement is 13 mm in diameter while the longitudinal reinforcement diameter is 10 mm

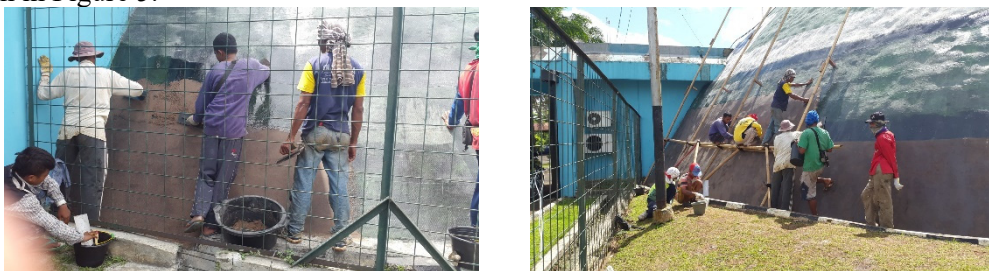
Figure 5: Instalment of CFRP to Strengthening Dome

From above analysis it is shown that the hoop reinforcement of the dome is inadequate at bottom portion until the height of 3.8 meters. This inadequacy should be strengthened.

Since inadequate reinforcing bars are embedded in the concrete, then it was not possible to insert additional reinforcing bars in the concrete. Another way to strengthening the hoop reinforcing bars was adopted. The method of repairment was to use carbon fibre reinforced plastic (CFRP). The need for CFRP material was computed as follows. The demand of CFRP usage on the lower area with height of $0.629 \times 22\text{m} = 13.838 \text{ m}$ is done as shown below. The total tension force is 1522.18 kN. the CFRP was needed is 304 mm^2 and reinforcement width required is 2.53 m.

Based on the safety factor, therefore, 3,8m was attached. The installment of the repairment is shown in Figure 5.
