# QUICK RESPONSE USING FORENSIC ENGINEERING ON STRUCTURAL BUILDING DAMAGE

## ABSTRACT

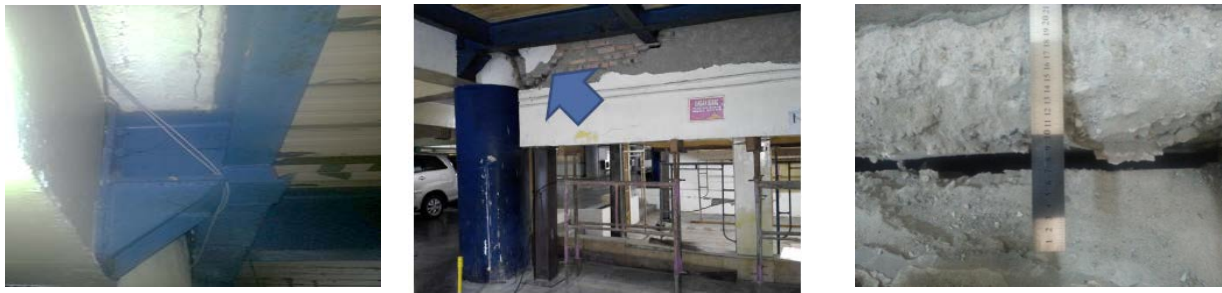
**Figure. 2.** Damage to the upper structure

The damage to the existing building structure is presented visually in Figure 2 and torsion is observed in the boundary beam between the old and new buildings due to the fact that the steel beams of the new buildings are connected to the old buildings beams instead of the columns. This has the ability to cause cracks in the slabs around the beams in the border area while the upper bolts at the steel beam joints in the new building as well as the old beams experience tension and look uneven as shown in Figure 2.

The visual results also showed shear cracks in the beams due to lack of connection to the column as well as the occurrence of non-uniform subsidence in the foundation as observed with the deformation in the basement floor, damage to brick walls, and broken slabs in the dilated area between the main and annex buildings.

The cause of the damage was triggered by a new project in dewatering work, near the building being investigated. The evidence is that there are eight buildings that suffered similar damage.

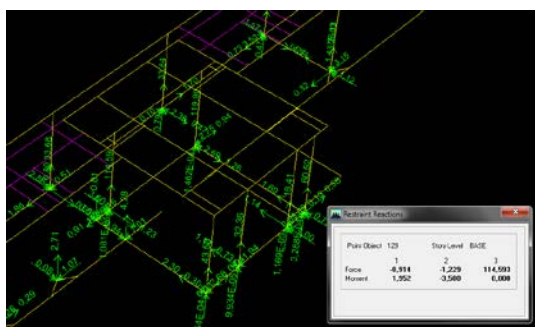
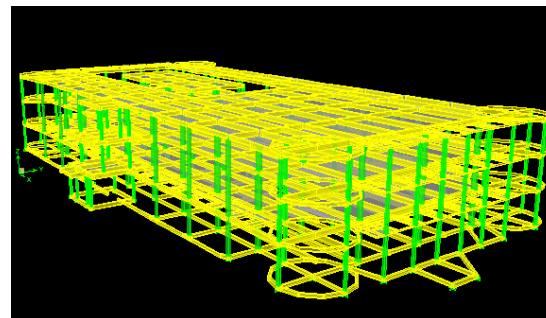
**Figure 3.** Modeling of the building structures due to gravity loads

The ultimate torsion load condition on the boundary beam due to the mounting of the new building's steel beam on the old building's concrete beam was observed to have led to the twisting which caused the cracks in the slabs. Moreover, an improper structural system was observed to have caused an uneven load distribution mechanism and this made certain columns to be heavy while others are much lighter. In this case, one column has an ultimate axial load of 114 tons while the surrounding columns are
