# Survey, investigation and repairing on concrete wall of waste water treatment building

**Abstract.** Waste Water Treatment Building of the Multi National Company located in Cikande of Banten Province in Indonesia has experienced a poor function due to seepage and leakage on its reinforced concrete walls. The height of the reinforced concrete wall was 12 meters. This paper describes the surveys, investigations and repair conducted to overcome the seepage and leaks in the reinforced concrete walls. The feasibility of its concrete was investigated using Ultrasonic Pulse Velocity (UPV). The feasibility of the concrete was reviewed based on 2 (two) factors: (1) homogeneity and (2) crack depth. The result of the survey and investigation showed that the quality of homogeneity was enough and was pretty good and the average crack depth was about  $h = 102,5$  mm. The method of repairing used was: (1) crack injection using epoxy, (2) leakage injection using cement modified polymer material and (2) waterproof coating using a cement-based coating. To prove the success of the repairing, pond testing was conducted for 14 days. Based on the test result, there was no leakage and seepage during

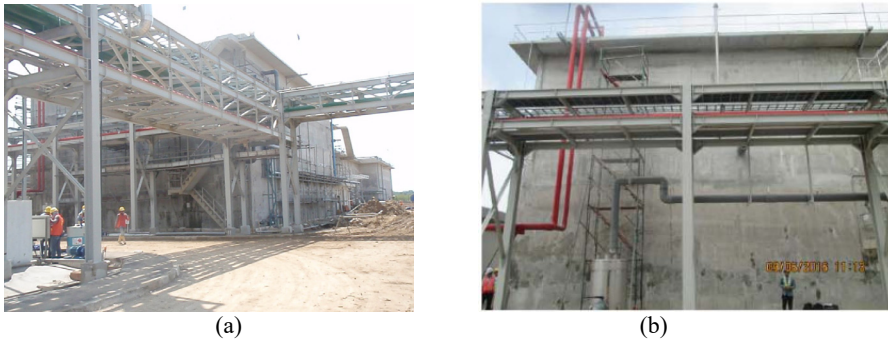
**Fig. 1.** Waste water treatment building: (a) condition of the plant and (b) the 12 m reinforced concrete wall.

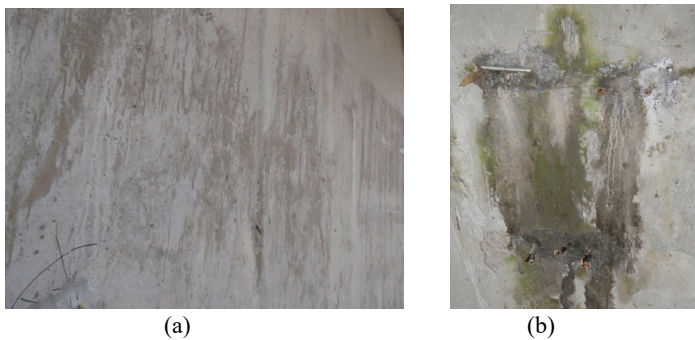
The Waste Water Treatment Building (WWTB) of the Multinational Company located in Cikande, Banten will be reviewed in this paper. This building used the construction of reinforced concrete walls as high as 12 meters. After construction, there was seepage and leakage in its wall. The wall encountered deterioration such as the presence of honeycomb/segregation of concrete and cracks. Based on the construction report, this deterioration was observed as a result of uncontrolled slumps so that the slump value did not comply and the level of compaction was not sufficient at the time of casting.

**Fig. 3.** Seepage on the wall: (a) surface area seepage on the wall W1 and (b) spot seepage on the wall W2.

Repair conducted is shown in Figure 6 to Figure 8. Crack injection stages are shown in Figure 6. The stages were (1) cleaning the crack surface from dust and other dirt, (2) cutting the crack, (3) setting an injection nipple, (4) injecting the epoxy, and (5) cleaning the surface with a grinder. Meanwhile, leakage injection is shown in Figure 7. The stages were (1) cleaning the crack surface from dust and other dirt, (2) cutting the crack, (3) setting injection nipple, (4) injecting the cement modified polymer material, and (5) cleaning the surface with a grinder. The waterproof coating is shown in Figure 8. The stages were (1) cleaning the crack surface from dust and other dirt, (2) applying waterproof coating for 1 layer, and (3) applying waterproof coating for 2 layers perpendicularly.

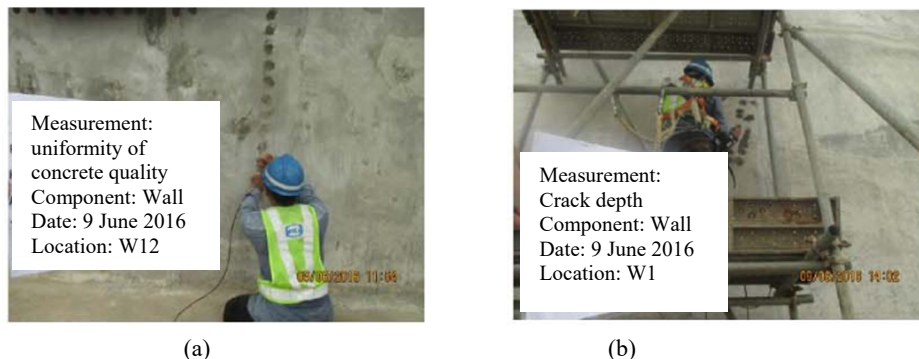
**Fig. 5.** UPV Testing: (a) UPV testing on concrete wall W12 (vertical) and (b) UPV testing on concrete wall W1 (for crack estimation).

No	Location/Wall	V (km/sec)	uniformity of concrete quality
1	Vertical/wall W12	3,24	pretty good
2	Horizontal/wall W12	2,34	enough
3	Horizontal/wall W1	3,05	pretty good
4	Vertical/wall W1	3,32	pretty good
5	Vertical/wall W3	2,99	enough

From the results of crack depth testing of wall W1, the average crack depth of 102.5 mm was obtained.

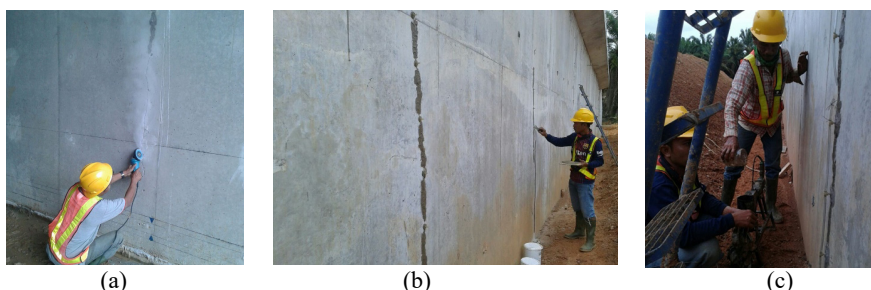
Fig. 6. Crack injection using epoxy: (a) cutting crack, (b) making injection nipple and (c) crack injection.

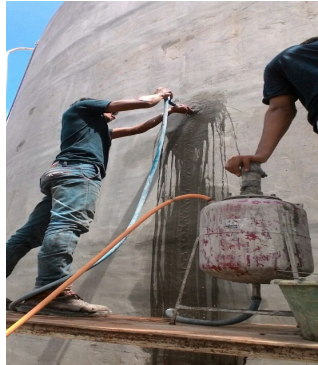
**Fig. 7.** Leakage injection using cement material with modified polymer.

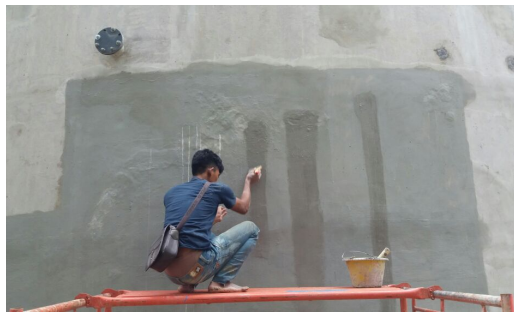
**Fig. 8.** Waterproof coating on the wall.

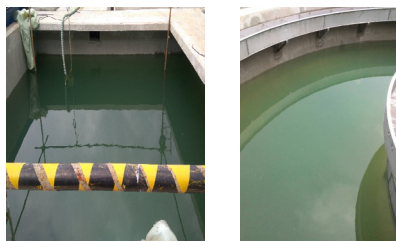
To prove the success of the repair, pond testing was conducted for 14 days as shown in Figure 9. Based on the test results, there was no leakage and seepage during the pond testing. WWTB was ready to use.

**Fig. 9.** Pond testing for 14 days.
