Survey, investigation and repairing on concrete wall of waste water treatment building

Partogi H Simatupang^{1,*} and Jonbi²

Abstract. Waste Water Treatment Building of the Multi National Company located in Cikande of Banten Province in Indonesia has experienced a poor function due to seepage and leakage on its reinforced concrete walls. The height of the reinforced concrete wall was 12 meters. This paper describes the surveys, investigations and repair conducted to overcome the seepage and leaks in the reinforced concrete walls. The feasibility of its concrete was investigated using Ultrasonic Pulse Velocity (UPV). The feasibility of the concrete was reviewed based on 2 (two) factors: (1) homogeneity and (2) crack depth. The result of the survey and investigation showed that the quality of homogeneity was enough and was pretty good and the average crack depth was about $h = 102,5$ mm. The method of repairing used was: (1) crack injection using epoxy, (2) leakage injection using cement modified polymer material and (2) waterproof coating using a cement-based coating. To prove the success of the repairing, pond testing was conducted for 14 days. Based on the test result, there was

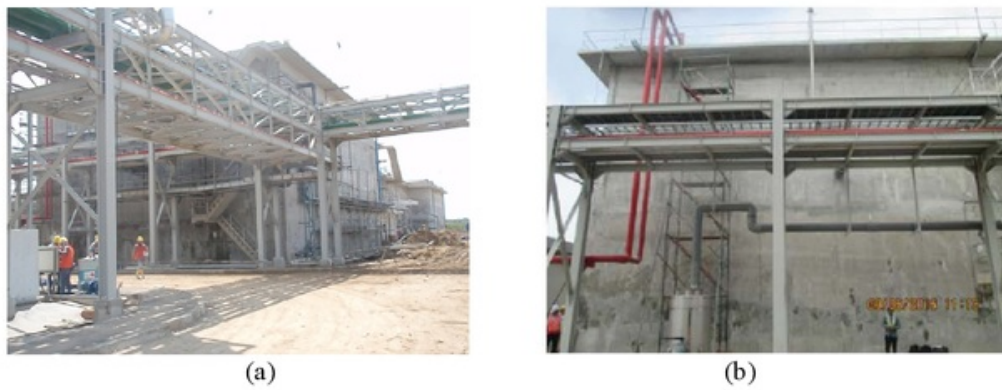
The Waste Water Treatment Building (WWTB) of the Multinational Company located in Cikande, Banten will be reviewed in this paper. This building used the construction of reinforced concrete walls as high as 12 meters. After construction, there was seepage and leakage in its wall. The wall encountered deterioration such as the presence of honeycomb/segregation of concrete and cracks. Based on the construction report, this deterioration was observed as a result of uncontrolled slumps so that the slump value did not comply and the level of compaction was not sufficient at the time of casting.

Fig. 1. Waste water treatment building: (a) condition of the plant and (b) the 12 m reinforced concrete wall.

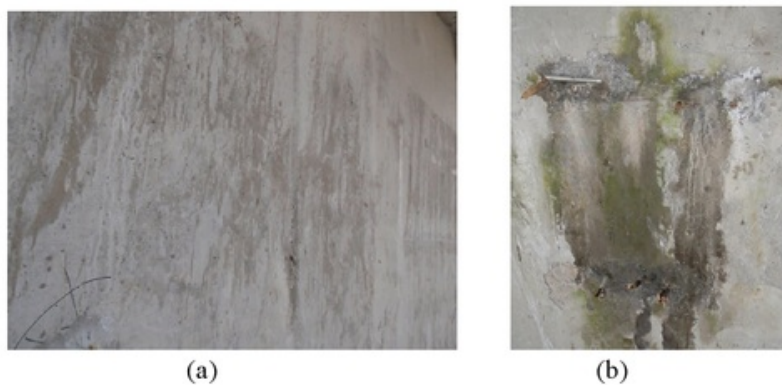
The Waste Water Treatment Building is shown in Figure 1a. Meanwhile, construction of the wall is shown in Figure 1b. The layout of the building is given in Figure 2. Some seeped walls are shown in Figure 3. Figure 3 shows seepage on the wall with the surface area seepage (Figure 3.a) and spot seepage (Figure 3.b).

Fig. 3. Seepage on the wall: (a) surface area seepage on the wall W1 and (b) spot seepage on the wall W2

Survey, investigation and repair work on WWTB concrete wall leakage has been presented. The leakage and seepage were caused by the inadequate quality of concrete work. An investigation conducted using UPV Testing showed that the quality of concrete was enough and had a pretty good quality with a crack depth of 102.5 mm.

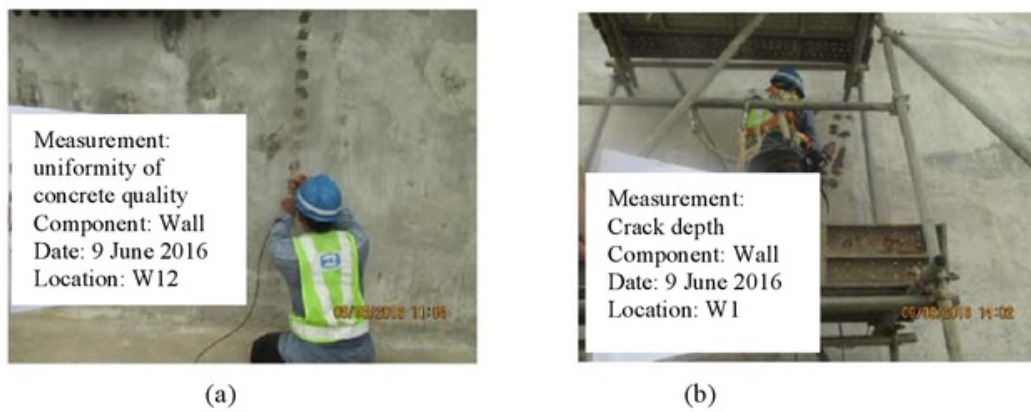
Fig. 5. UPV Testing: (a) UPV testing on concrete wall W12 (vertical) and (b) UPV testing on concrete wall W1 (for crack estimation).

No	Location/Wall	V (km/sec)	uniformity of concrete quality
1	Vertical/wall W12	3,24	pretty good
2	Horizontal/wall W12	2,34	enough
3	Horizontal/wall W1	3,05	pretty good
4	Vertical/wall W1	3,32	pretty good
5	Vertical/wall W3	2,99	enough

From the results of crack depth testing of wall W1, the average crack depth of 102.5 mm was obtained.

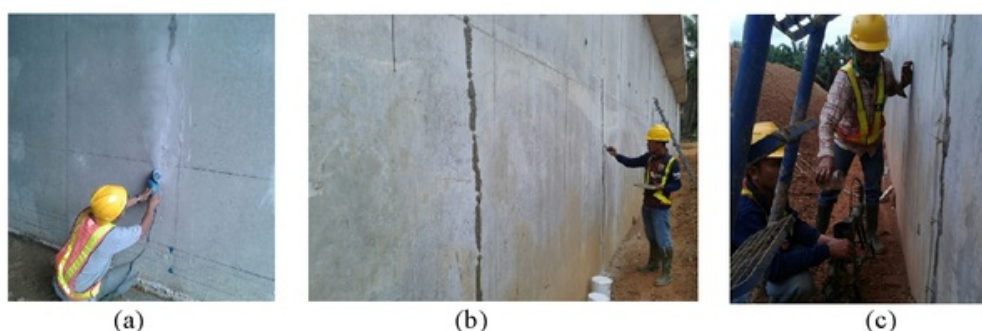
Fig. 6. Crack injection using epoxy: (a) cutting crack, (b) making injection nipple and (c) crack injection.

Repair conducted is shown in Figure 6 to Figure 8. Crack injection stages are shown in Figure 6. The stages were (1) cleaning the crack surface from dust and other dirt, (2) cutting the crack, (3) setting an injection nipple, (4) injecting the epoxy, and (5) cleaning the surface with a grinder. Meanwhile, leakage injection is shown in Figure 7. The stages were (1) cleaning the crack surface from dust and other dirt, (2) cutting the crack, (3) setting injection nipple, (4) injecting the cement modified polymer material, and (5) cleaning the surface with a grinder. The waterproof coating is shown in Figure 8. The stages were (1) cleaning the crack surface from dust and other dirt, (2) applying waterproof coating for 1 layer, and (3) applying waterproof coating for 2 layers perpendicularly.

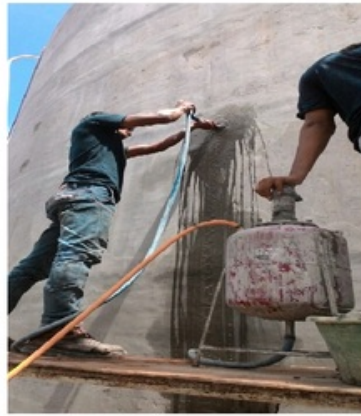
Fig. 7. Leakage injection using cement material with modified polymer.

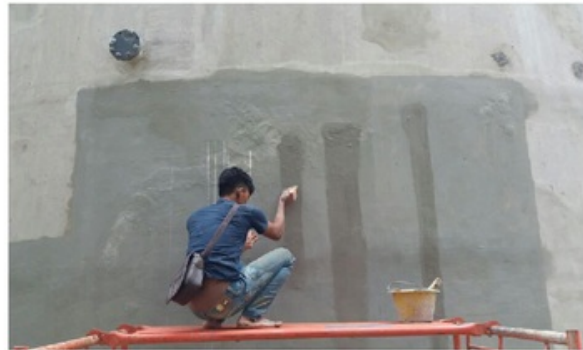
Fig. 8. Waterproof coating on the wall.

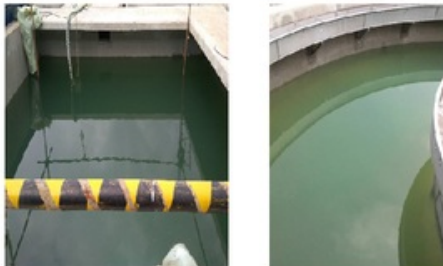
To prove the success of the repair, pond testing was conducted for 14 days as shown in Figure 9. Based on the test results, there was no leakage and seepage during the pond testing. WWTB was ready to use.

Fig. 9. Pond testing for 14 days.
