QUICK RESPONSE USING FORENSIC ENGINEERING ON STRUCTURAL BUILDING DAMAGE

Jonbi¹

Quick response and emergency when buildings are damaged by earthquakes and other situations to determine the causes and ensure that the structure of the building can still be used safely. The additional building of one the heritage buildings in Jakarta currently being used as an office was observed to have suffered damages in the form of torsion of the beams, cracks in beams and walls, as well as the subsidence in floors. Therefore, this research was conducted to investigate these sudden and quick damages using forensic engineering through visual observations, Ultrasonic Pulse Velocity testing, Profometer, Cone Penetration Test, Ground Penetrating Radar, and structural analysis. The visual observation results showed the existence of cracks in the beams, walls, and columns as well as a maximum deformation of 94 mm, especially in the dilation area or the border between the main building and the additional building around the lobby and the floors above it. Moreover, the improper structural system caused the damage as observed with one column having an ultimate axial load of 114 tons while the surrounding

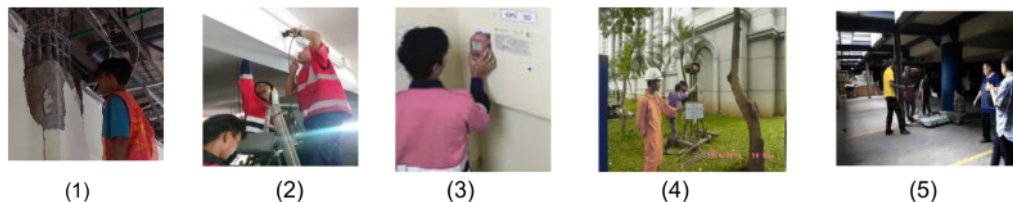
Figure 1. The test is carried out (1) visual observation. (2) UPV. (3) profometer. (4) CPT (5) GPR

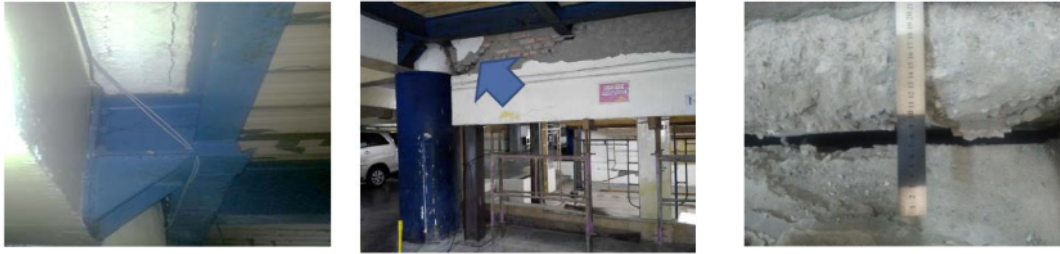
The damage to the existing building structure is presented visually in Figure 2 and torsion is observed in the boundary beam between the old and new buildings due to the fact that the steel beams of the new buildings are connected to the old buildings beams instead of the columns. This has the ability to cause cracks in the slabs around the beams in the border area while the upper bolts at the steel beam joints in the new building as well as the old beams experience tension and look uneven as shown in Figure 2.

Figure. 2. Damage to the upper structure

The visual results also showed shear cracks in the beams due to lack of connection to the column as well as the occurrence of non-uniform subsidence in the foundation as observed with the deformation in the basement floor, damage to brick walls, and broken slabs in the dilated area between the main and annex buildings.

The cause of the damage was triggered by a new project in dewatering work, near the building being investigated. The evidence is that there are eight buildings that suffered similar damage.

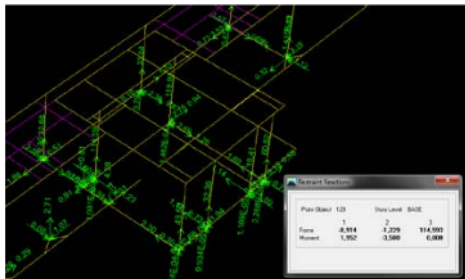
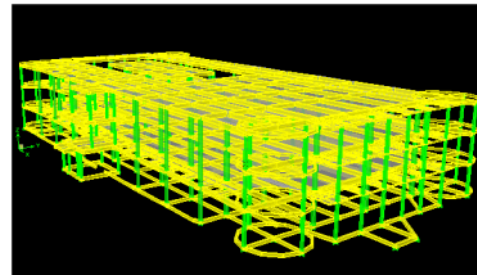
Figure 3. Modeling of the building structures due to gravity loads

The ultimate torsion load condition on the boundary beam due to the mounting of the new building's steel beam on the old building's concrete beam was observed to have led to the twisting which caused the cracks in the slabs. Moreover, an improper structural system was observed to have caused an uneven load distribution mechanism and this made certain columns to be heavy while others are much lighter. In this case, one column has an ultimate axial load of 114 tons while the surrounding columns are

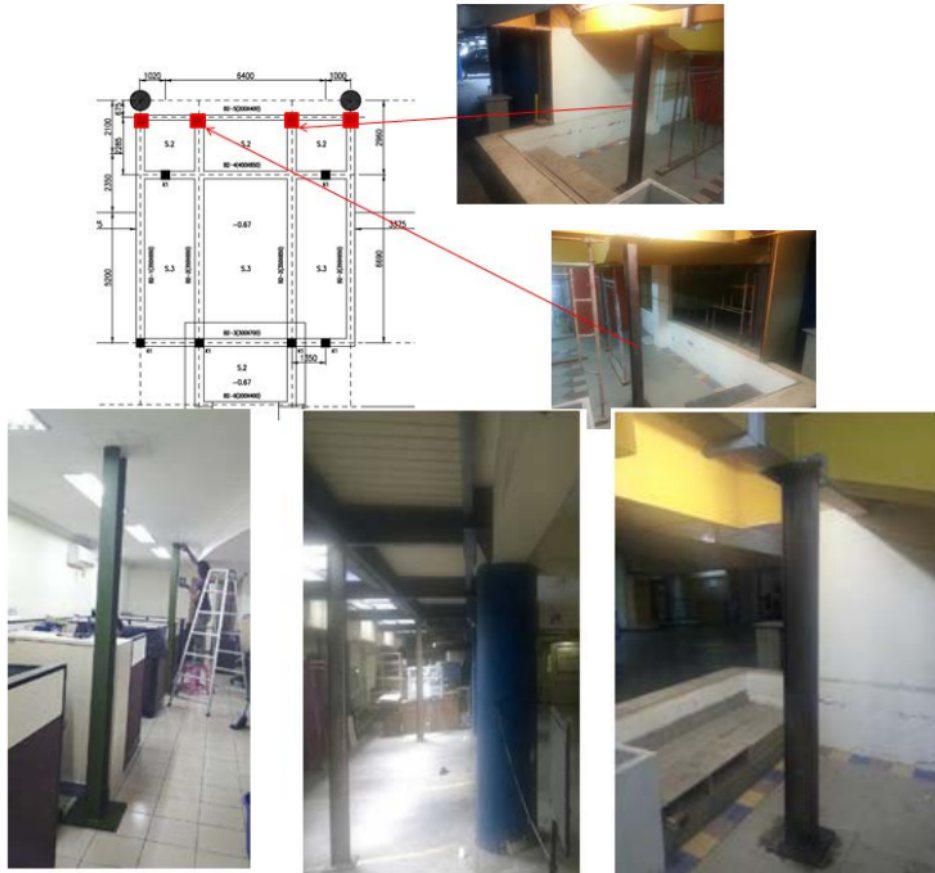
Figure 4. Temporary strengthening of the basement floor

These were placed in the basement at the lobby area as well as the right and left wings of the lobby as shown in Figure 4.

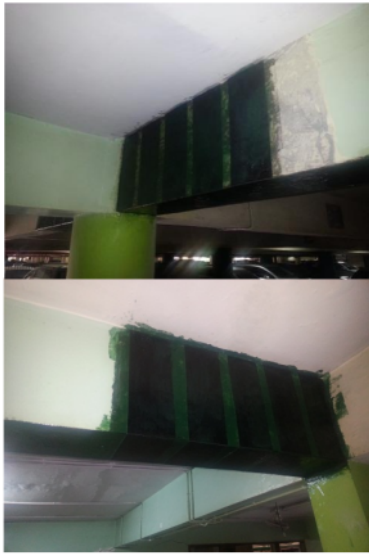
The beams in the basement are cracked as a result of the transfer due to the lack of support from the column as shown in Figure 5. Therefore, FRP was used as the strengthening material due to its lightness, high stiffness, corrosion resistance, fast installation, and low maintenance costs.

Figure 5. FRP strengthening of beam on first floor.

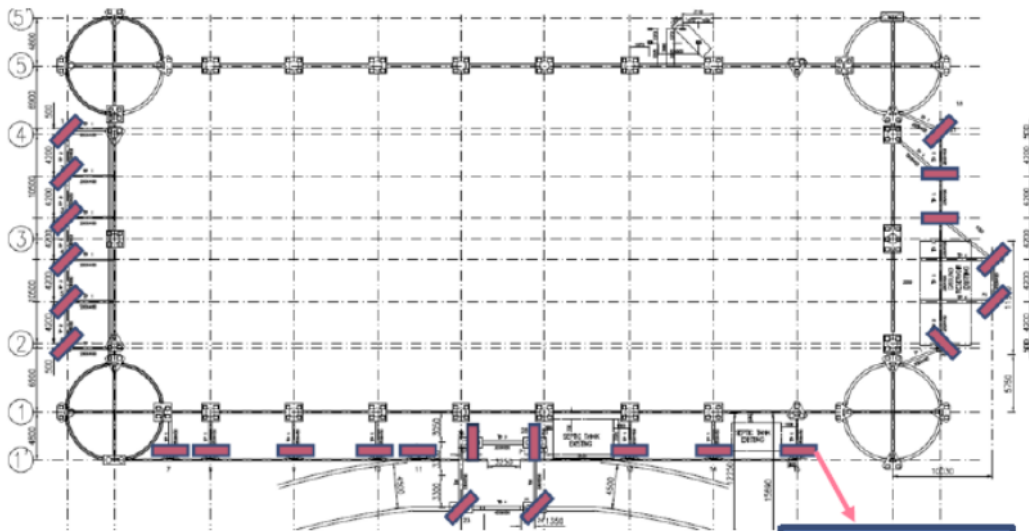
Figure 6. Strengthening with a new foundation

In principle, this system creates a new foundation as indicated in Figure 5 to support the old foundation. This is in the form of a bore pile with 30 m depth which was designed and implemented using an underpinning system as indicated in Figure 6 based on several considerations such as the limited workspace, not being noisy, and not disturbing the operation of an office building. This makes it possible for the structure to protect the old foundation and the structure it carries from the subsidence damage due to changes in soil conditions. Moreover, all the points of the foundation were reinforced but the repairment cannot be quickly conducted due to the limited field conditions which led to a longer period of work.

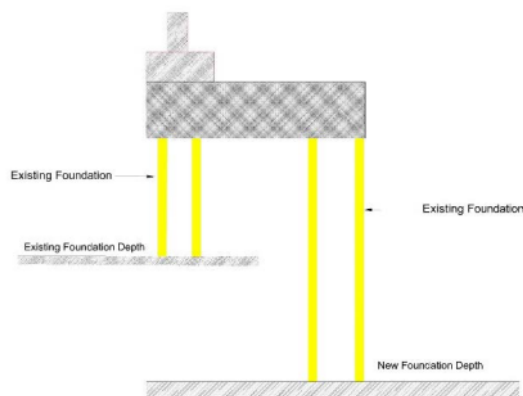
Figure 7. Underpinning method for strengthening existing foundations
