# Survey, investigation and repairing on concrete wall of waste water treatment building

**Abstract.** Waste Water Treatment Building of the Multi National Company located in Cikande of Banten Province in Indonesia has experienced a poor function due to seepage and leakage on its reinforced concrete walls. The height of the reinforced concrete wall was 12 meters. This paper describes the surveys, investigations and repair conducted to overcome the seepage and leaks in the reinforced concrete walls. The feasibility of its concrete was investigated using Ultrasonic Pulse Velocity (UPV). The feasibility of the concrete was reviewed based on 2 (two) factors: (1) homogeneity and (2) crack depth. The result of the survey and investigation showed that the quality of homogeneity was enough and was pretty good and the average crack depth was about  $h = 102,5$  mm. The method of repairing used was: (1) crack injection using epoxy, (2) leakage injection using cement modified polymer material and (2) waterproof coating using a cement-based coating. To prove the success of the repairing, pond testing was conducted for 14 days. Based on the test result, there was no leakage and seepage during

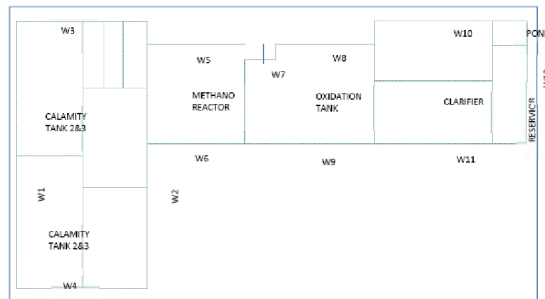
**Fig. 2.** Layout of waste water treatment building.

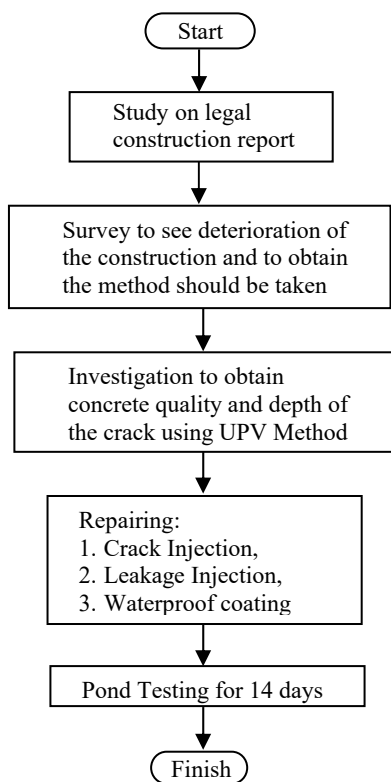
The work steps performed are given in Figure 4. The work was preceded by a study of the legal report of construction. This work aims to get an idea of the things that happen during the construction stage, especially the concrete work. The next step is the survey. This survey aims to get an overall damage description, sketches of location and dimension of the damage. Then, it can be decided what investigation needs to be done.

Investigations that need to be done were crack depth testing and quality of concrete testing. The repairing method that needs to be done were: (1) crack injection, (2) leakage injection and (3) waterproof coating. After repairing was conducted, it was necessary to conduct a reliability testing on the repairing structure. Reliability testing conducted was the pond testing for 14 days with the intention of seeing the presence or absence of seepage that may occur.

Fig. 4. Low chart of work.
