Survey, investigation and repairing on concrete wall of waste water treatment building

Partogi H Simatupang^{1,*} and Jonbi²

Abstract. Waste Water Treatment Building of the Multi National Company located in Cikande of Banten Province in Indonesia has experienced a poor function due to seepage and leakage on its reinforced concrete walls. The height of the reinforced concrete wall was 12 meters. This paper describes the surveys, investigations and repair conducted to overcome the seepage and leaks in the reinforced concrete walls. The feasibility of its concrete was investigated using Ultrasonic Pulse Velocity (UPV). The feasibility of the concrete was reviewed based on 2 (two) factors: (1) homogeneity and (2) crack depth. The result of the survey and investigation showed that the quality of homogeneity was enough and was pretty good and the average crack depth was about $h = 102,5$ mm. The method of repairing used was: (1) crack injection using epoxy, (2) leakage injection using cement modified polymer material and (2) waterproof coating using a cement-based coating. To prove the success of the repairing, pond testing was conducted for 14 days. Based on the test result, there was

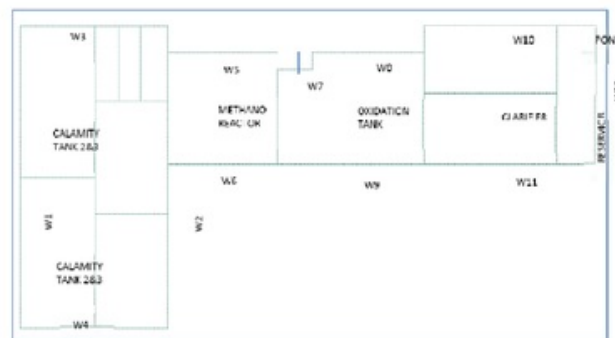
Fig. 2. Layout of waste water treatment building.

The Waste Water Treatment Building is shown in Figure 1a. Meanwhile, construction of the wall is shown in Figure 1b. The layout of the building is given in Figure 2. Some seeped walls are shown in Figure 3. Figure 3 shows seepage on the wall with the surface area seepage (Figure 3.a) and spot seepage (Figure 3.b).
