Repair Methods and Applications to overcome Honeycomb, Cold Joint and Cracks in Concrete

ABSTRACT : In concrete work with structural complexity and large volume of concrete, damage to concrete often occurs such as honeycomb, cold joints and cracks. Damage is caused by internal and external factors and becomes a serious problem, it is not uncommon for demolition of the building to be carried out. Demolition is the last option, for that it is necessary to carry out several stages starting with root cause analysis whose aim is to find out what are the main factors causing damage to the concrete. Then forensic engineering is carried out through visual observation, UPV test, profometer, coredrill with the aim of knowing the quality of the existing concrete and the damage that occurs. The next stage of improvement is through the repair method in the form of grouting, material patching, and injection. Through proper and accurate application, the problem of damage can be solved. Based on the results of the work carried out in the field, it shows good results, so that it can solve the problem of honeycomb, cold joints and cracks that occur. These results prove that the development of concr

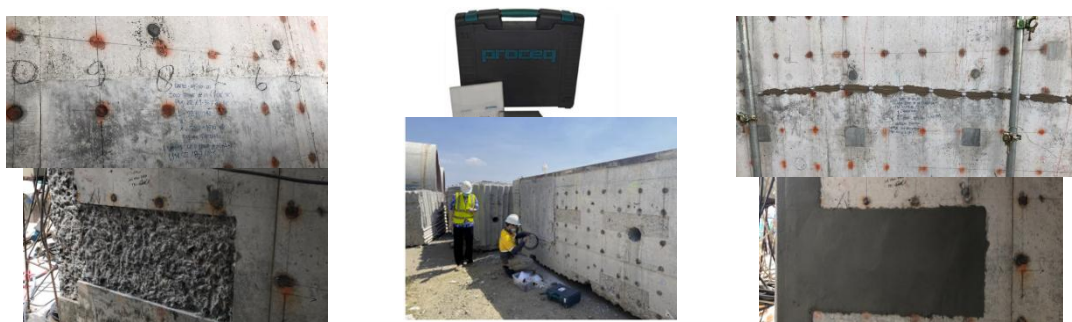
Figure 1. repair work control: before, testing and after work

Fourth stage :determine the repair method according to the type of damage that exists by referring to the standards issued by the american concrete institute [12-13].Fifth stage : material selection for repair of structural concrete fillings. material is selected based on material from several manufacturers such as BASF, SIKA and FOSROC, the basis for selection is mechanical properties, material availability and price. The procedure begins with identifying the cause of the damage and assessing the concrete substrate, and continues with evaluate the mechanical properties and durability of the selected [14-15]. The sixth step: the implementation of repair work in accordance with the methods and materials selected for the type of damage that exists. The seventh step is to control the results of the repair work.To check the success of the work, it is necessary to test the compressive strength of the grouting and patching materials. Additional testing for patching work is carried out with a bond strength test with a pull out test, then on the control concrete injection work in the form of a UPV test before and after the repair is carried out. As shown in Figure 1.

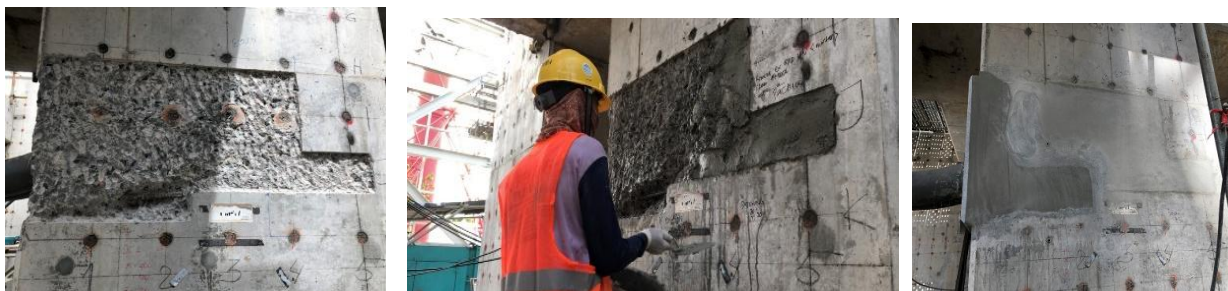
Figure 2. Honeycomb from 10 mm up to 10 mm upto less than 50 mm and concrete cover less than 40 mm

Type 1. Patching for Honeycomb from 10 mm up to less than 50 mm and concrete cover less than 40 mm(Fig.2)

Repair method and application : preparatory work: The surface that has been checked is sure to meet the requirements of a concrete cover \geq 50 mm, Clean from dirt or dust. Primer with styrene Butadiene Rubber (SBR)Start the patch job by using a hand trowel Material Master Emaco S 5400 is a cementitious, polymer modified, one component, repair mortar containing reactive microsilica. Technical Properties Compressive Strength 28 days \geq 70 MPa and adhesion to concrete \geq 2 MPa

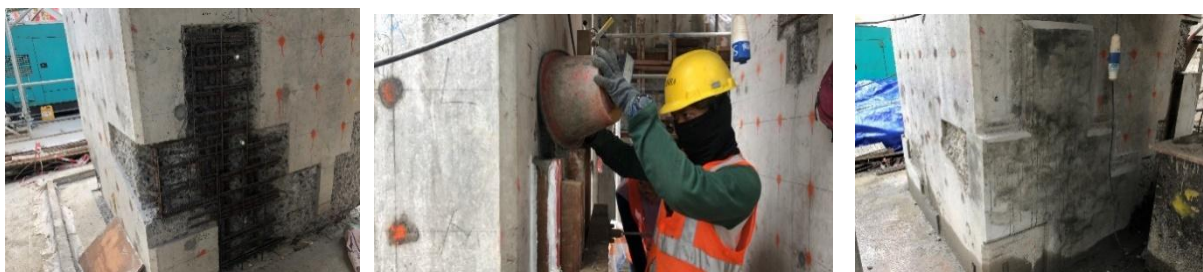
Figure 3. Honeycomb from 50 mm up to 100 mm

Type 2. Grouting Honeycomb from 50 mm up to 100 mm (Fig.3)

Repair method and application: chipping existing honeycomb, until it passes through reinforcement which is at least 10 mm. Chipping uses Hydraulics, to avoid damage to work. Chipping must be done by repair worker. Chipping is adjusted according to the existing damage zone. Install the shear connector every 250-400mm depending on the surface area to be grouted. Install formwork and attach strong and not leak. After everything is ready, Grouting can be done using a grout pump or pouring system by using for certain positions. Material shear connector is HILTI anchor HUS3-H Type

Material for Grouting: MasterFlow 880 is non-shrink, iron aggregate precision grout with high early and ultimate strength. It is typically placed at a flowable consistency at thickness between 10 mm and 150 mm. Technical properties: Compressive strength $>$ 90 MPa and Flexural strength $>$ 90 MPa after 28 days.

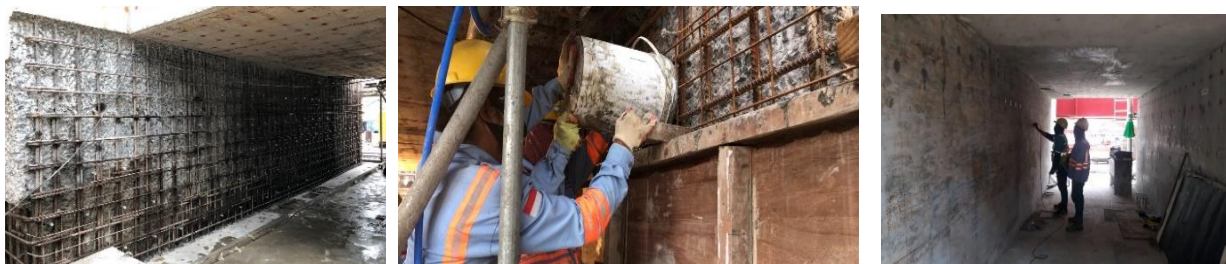
Figure 4. Large Honeycomb

Type 3. Grouting and injection Deepest Honeycomb (Fig.4)

Repair method and application : the injection packers inserted into pre-drilled holes shall be fixed at intervals along the length of each crack. Injection point drill depth is adjusted by internal honeycomb or at least 100 mm. The distance between each packer will depend upon the width and depth of the crack. Spacing shall be close enough to ensure that the resin will penetrate along the crack to the next point of injection. This will normally be between 100 mm and 200 mm. Before the grout work is carried out, the formwork installed must be strong, not leaky and use good materials to produce a flat concrete surface that is repaired. Masterflow 880 has good flow properties, so it can fill the deepest honeycomb. Meanwhile, to fill a small void, the injection pipe must be installed/ prepared, the pipe size is longer than the thick grouting. After everything is ready, installation work with Masterflow 880 can be done using a grout pump. then after 1 x 24 hours, injection work with epoxy to fill a small vacuum can be do Material for Grouting: MasterFlow 880 is non-shrink, iron aggregate precision grout with high early and ultimate strength. It is typically placed at a flowable consistency at thickness between 10 mm and 150 mm. Technical properties: Compressive strength > 90 MPa and Flexural strength > 90 MPa after 28 days. Material for injection : Conbextra EP10TG epoxy is a two part, solvent-less, low viscosity, non-shrink epoxy resin system that forms a permanent bond and seal in cracks in concrete. Crack widths between 0.25 mm - 10 mm can be treated. This epoxy is designed to be injected into cracks using suitable resin injection equipment. The injection pressure should be at least 0.4 N/mm^2 (4 Bar). Technical data : Compressive strength 7 days : 83 N/mm^2 , flexural strength : 63 N/mm^2

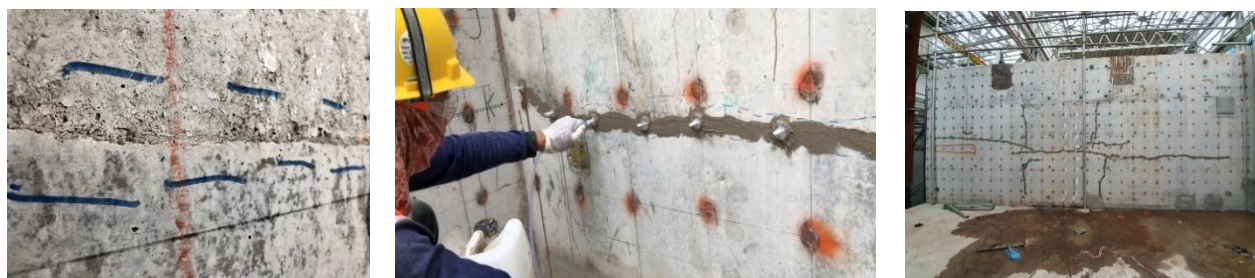
Figure 5. Repair work cold joint and cracks

Type 4. Injection with Epoxy to repair cold joint and cracks(Fig. 5)

Repair method and application : injection point nipple is affixed along the crack using epoxy sealing, which must be installed at intervals along the length of each crack. The distance between each packer will depend upon the width and depth of the crack. Spacing shall be close enough to ensure that the resin will penetrate along the crack to the next point of injection. This will normally be between 100 mm and 200mm.

Material for injection: Conbextra EP10TG epoxy is a two part, solvent-less, low viscosity, non-shrink epoxy resin system that forms a permanent bond and seal in cracks in concrete. Crack widths between 0.25 mm - 10 mm can be treated. This epoxy is designed to be injected into cracks using suitable resin injection equipment. The injection pressure should be at least 0.4 N/mm^2 (4 Bar). Technical data : Compressive strength 7 days : 83 N/mm^2 , flexural strength : 63 N/mm^2

Epoxy injection work, if carried out with the correct repair method, has been proven to be able to overcome the problem of cold joints and cracks, this is in line with research conducted by several researchers [16].

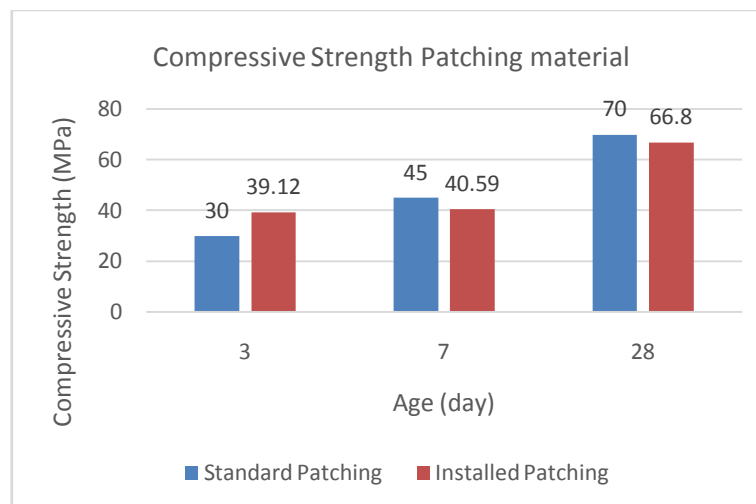
Figure 7. Compressive strength patching material

The results of the patching material test that have been applied in the field and the grout standard from the producer show significant results as shown in Figure 7. The standard patching material from the producer for 3 days > 30 MPa, 7 days > 45 MPa and 28 days > 70 MPa. Then the results of field tests for 3, 7, 28 days were 39.12 MPa, 40.59 MPa and 66.8 MPa. These results show the results of the compressive strength in the field reaching 95.4%, this is due to the weather conditions during application repair in the field, but these results are still acceptable
